SILICONE ROOFING RESTORATION

A spray foam roof installation completed 16 years ago required just a touch of Silicone coating to renew the previous SEBS coated spray foam roof system. The original standing seam, metal panel roofing system with a low slope to drain, had numerous water leaks. For the building owner and for the tenant, **Board of Cooperative Education**, water leaks were unacceptable.

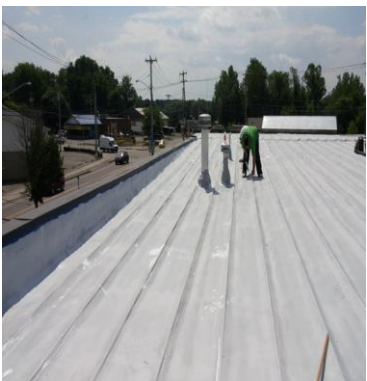
A Sprayed Polyurethane Roofing system was the answer. It provided a seamless, insulated and totally adhered solution. Now, fast-forward 16 years later... weathering of the coated spray foam had resulted in erosion of the previous coating, but still no leaks.
