## Mixed Nuts: A Polyurea and Silicone Roofing System Halts Leaks at a New York-based Nut Butter Factory

### A polyurea and silicone roofing system halts leaks at a New York-based nut butter factory

By Juan Sagarbarria (Spray Foam Magazine)

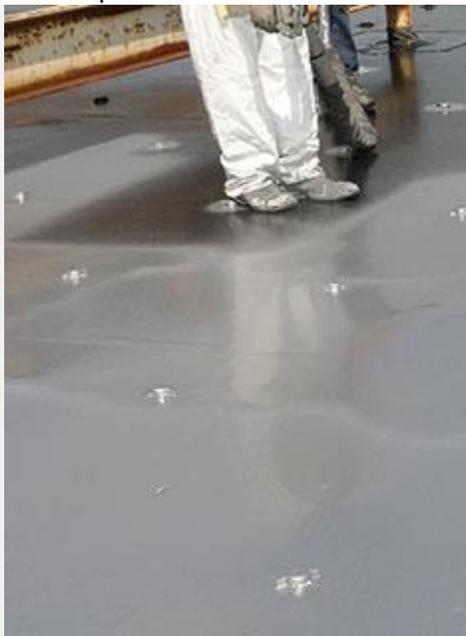
The WTI crew primed the flat surface of the roof and installed perimeter flagging prior to the coatings application. Spray foam was applied to the perimeter of the roof to eliminate shrinkage of the roof membrane

“The existing EPDM had noted holes and defects, which had released the membrane from the outer perimeter,” said Ezard. “It was pulled pretty tight, so we had to relief cut the membrane and refasten it every 12 inches into the metal decking. The spray foam successfully

encapsulated the outer perimeter over the wood blocking and onto the refastened EPDM membrane.”

Once the primer flashed off, the WTI crew used a Graco Probler P2 gun to apply the base coat, which was silver Oak Ridge ORSLM Pure Polyurea at a minimum thickness of 1.5 gallons per square. The crew first applied the polyurea to all seams twice followed by an overlay to the entire substrate. During the polyurea application, the WTI crew divided itself to begin the silicone topcoat application so that one part of the crew focused on completing the polyurea application and the others followed immediately with the topcoat. The topcoat consisted of the installation of 18 dry mils of Oak Ridge’s 78 percent solid, single-component White Silicone coating. The two-coat application totaled approximately a 48-mil dry film thickness.
